**DOT/FAA/AR-96/21**

# **Composite Failure Analysis Handbook Update 1**

**WL-TR-93-4004**

August 1997

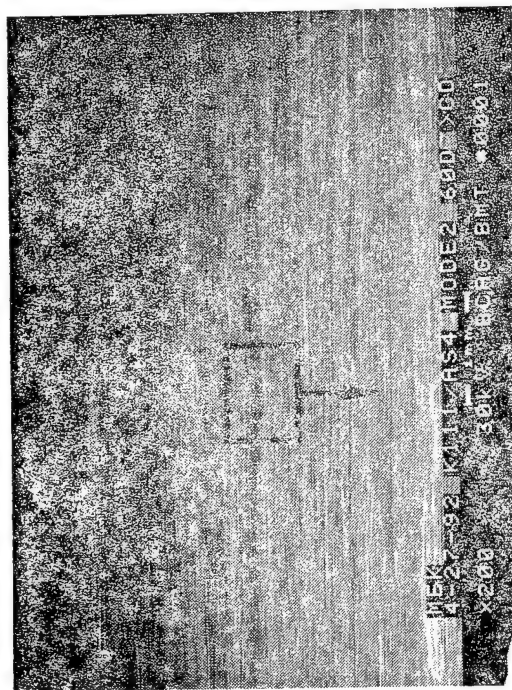
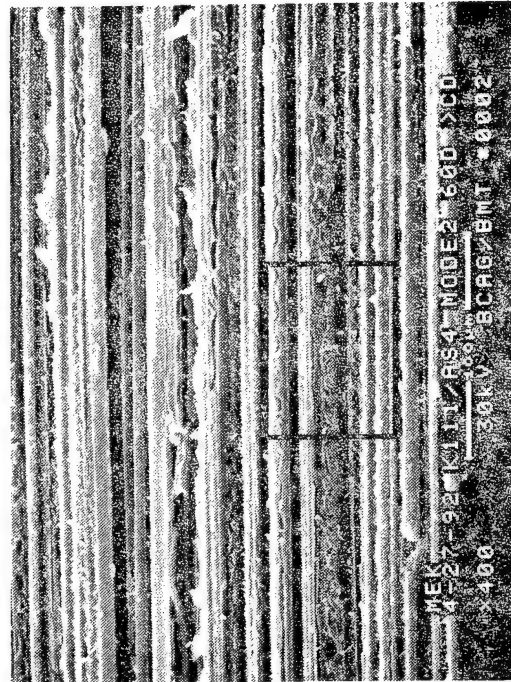
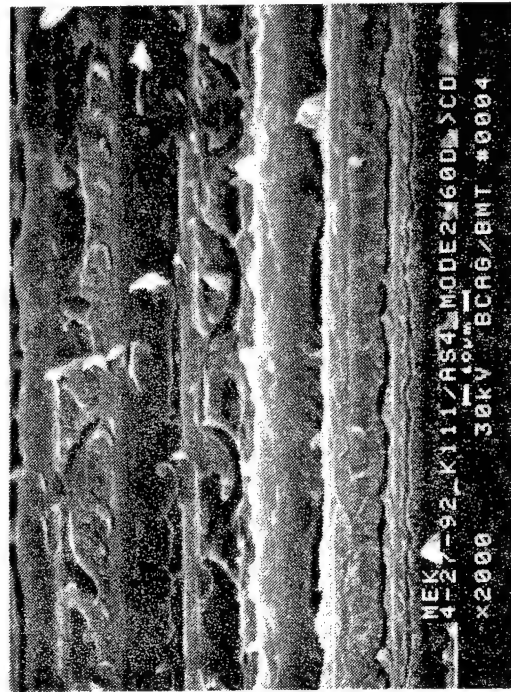
Figure 3.2-22. SEM Fractographs of a K11/AS4 Interlaminar Mode II Shear Fracture Surface Exposed to MEK for 24 Hours

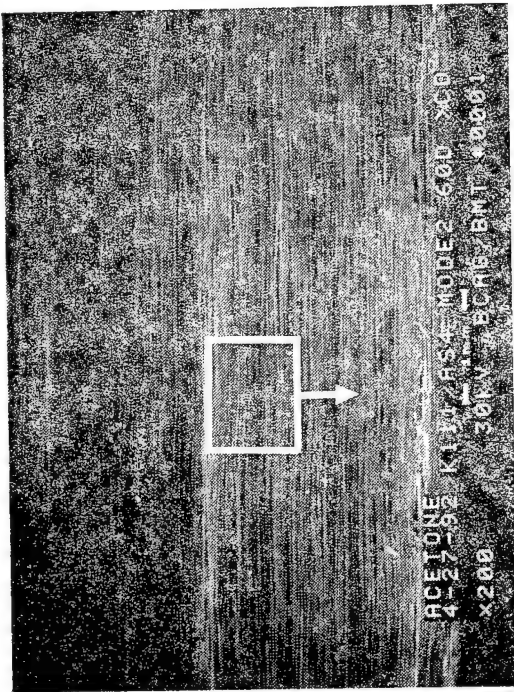
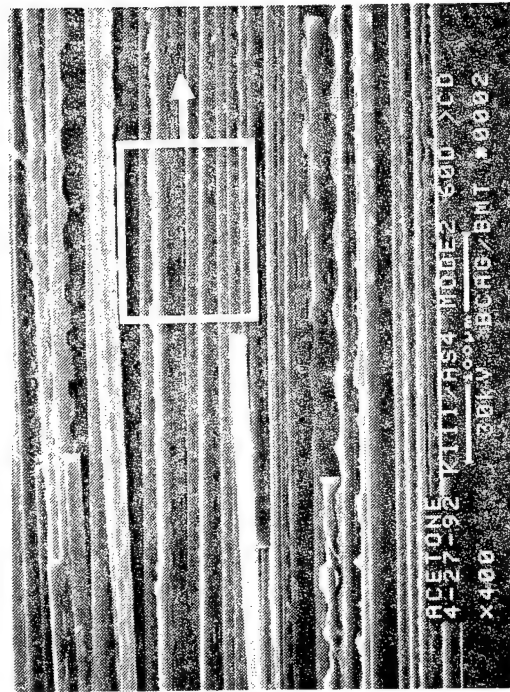
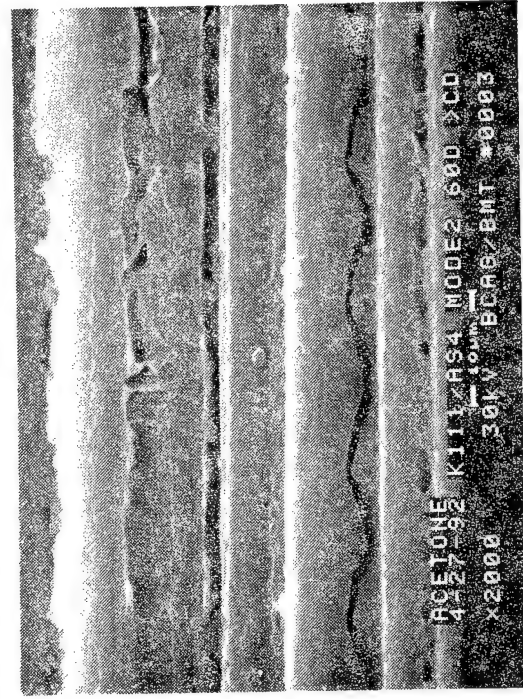
Figure 3.2-23. SEM Fractographs of a K111/AS4 Interlaminar Mode II Shear Fracture Surface Exposed to Acetone for 24 Hours

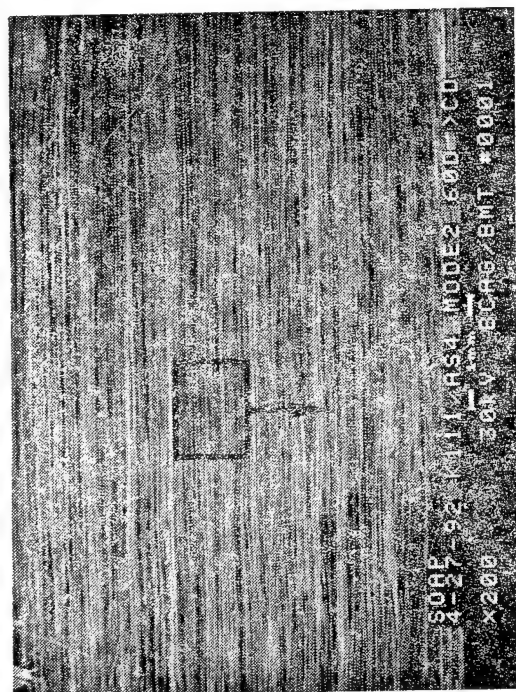
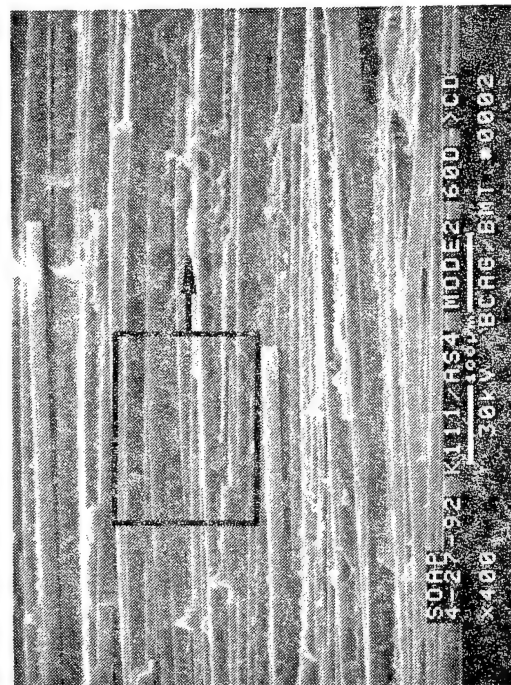
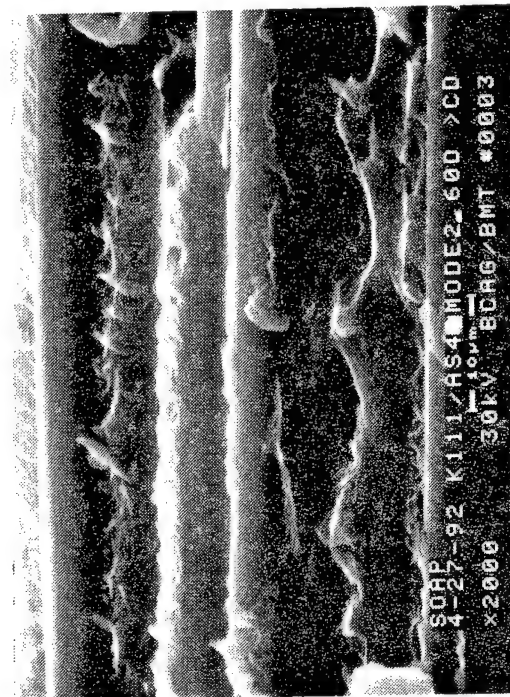
Figure 3.2-24. SEM Fractographs of a K111/AS4 Interlaminar Mode II Shear Fracture Surface Exposed to Soap Solution for 24 Hours

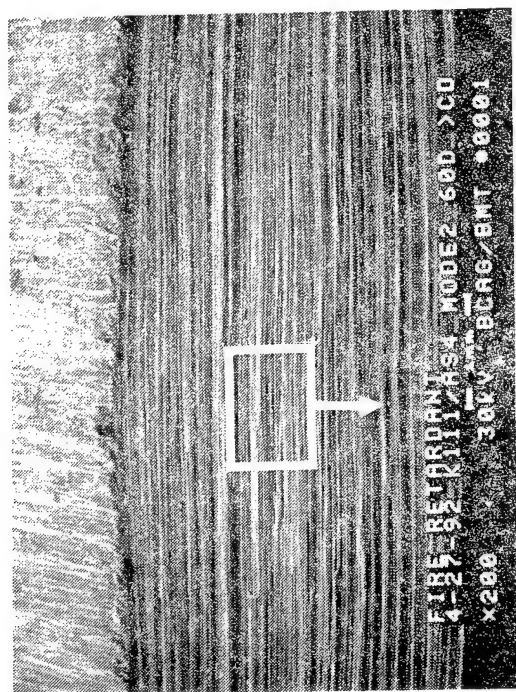
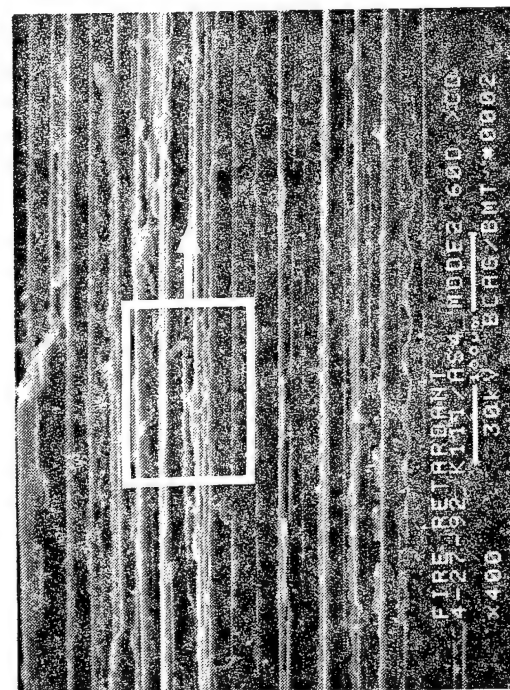
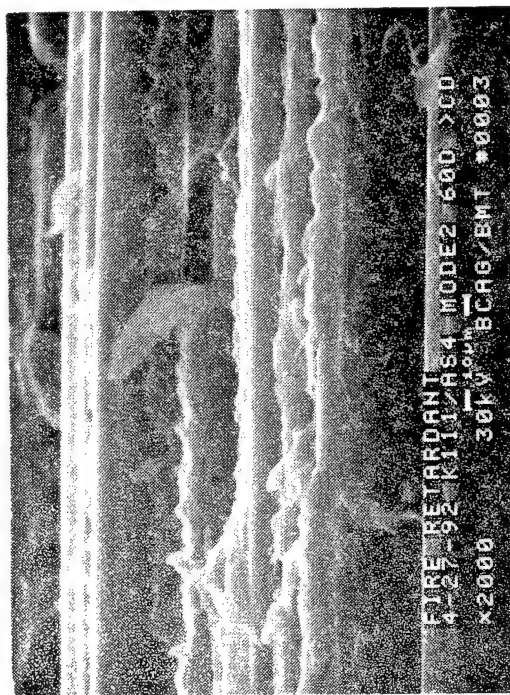
Figure 3.2-25. SEM Fractographs of a K111/AS4 Interlaminar Mode II Shear Fracture Surface Exposed to Fire Retardant Foam for 7 Days

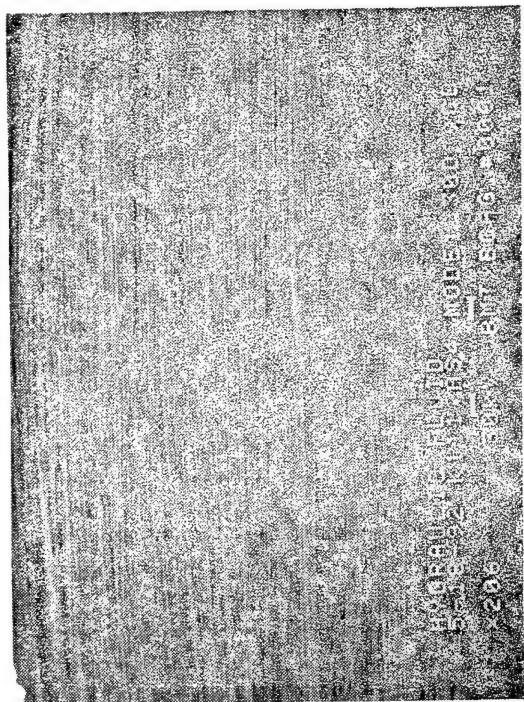
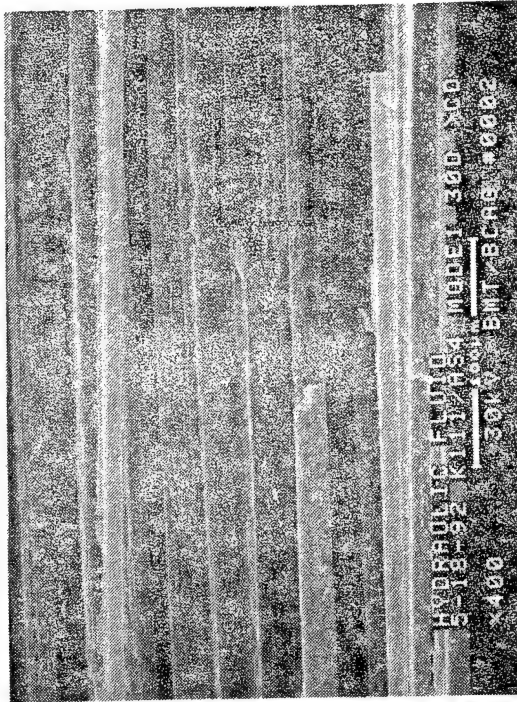
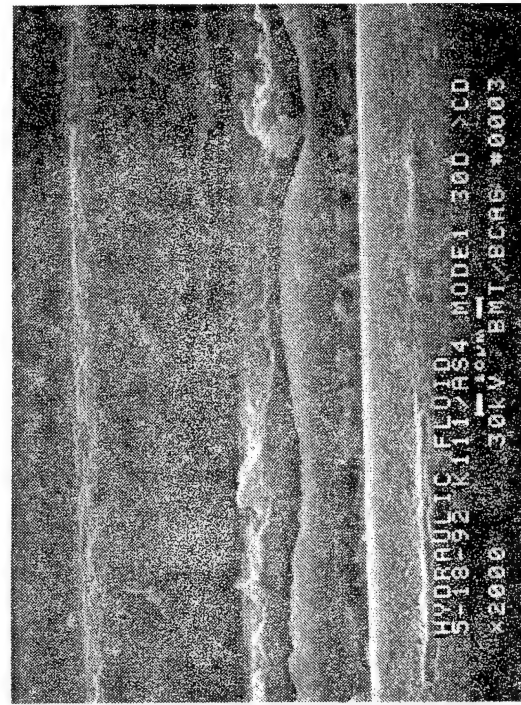
Figure 3.2-26. SEM Fractographs of a KIII/AS4 Interlaminar Mode I Tension Fracture Surface Exposed to Hydraulic Fluid for 7 Days

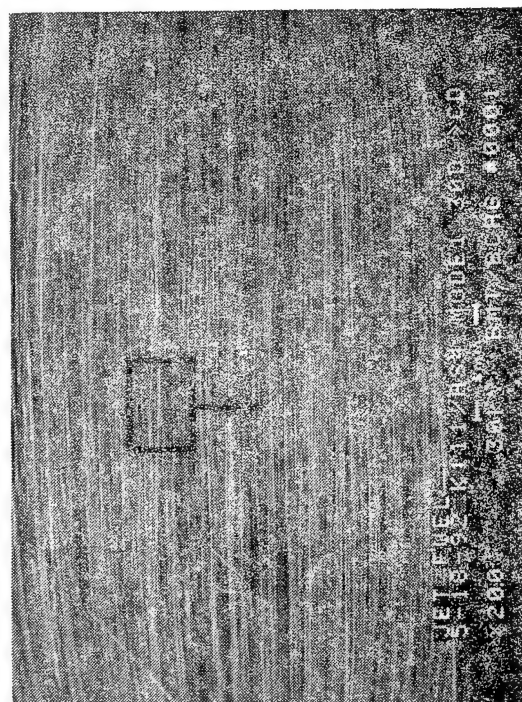
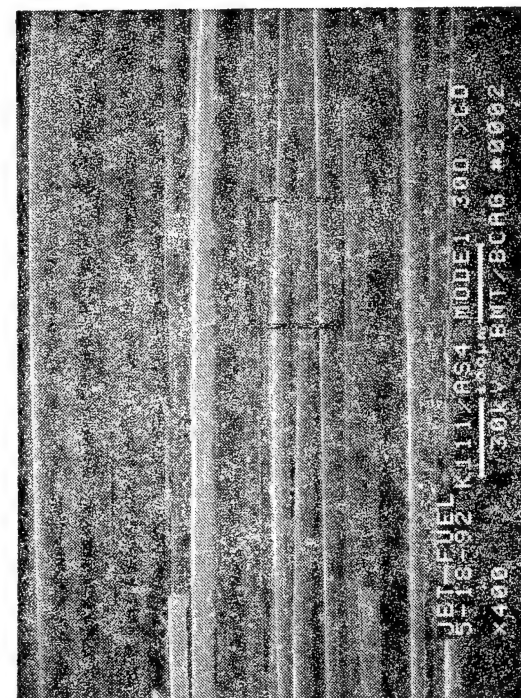
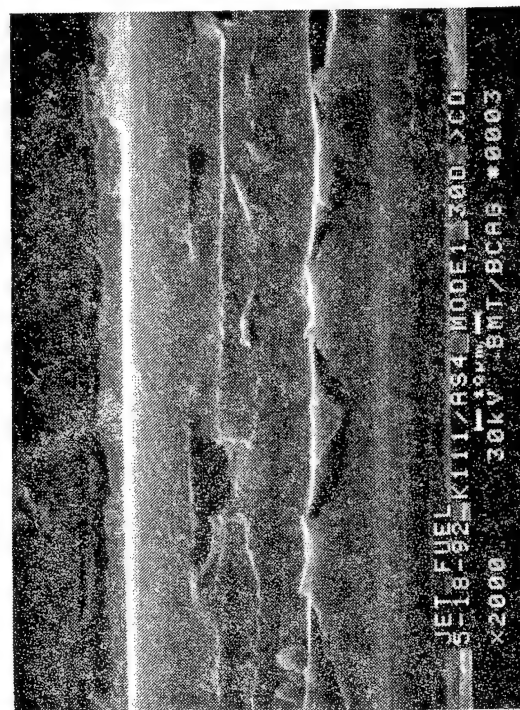
Figure 3.2-27. SEM Fractographs of a K111AS4 Interlaminar Mode I Tension Fracture Surface Exposed to JP4 Jet Fuel for 7 Days

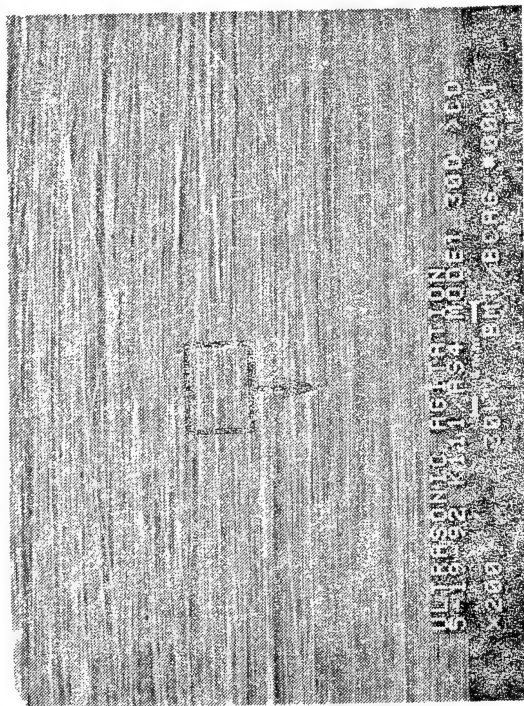
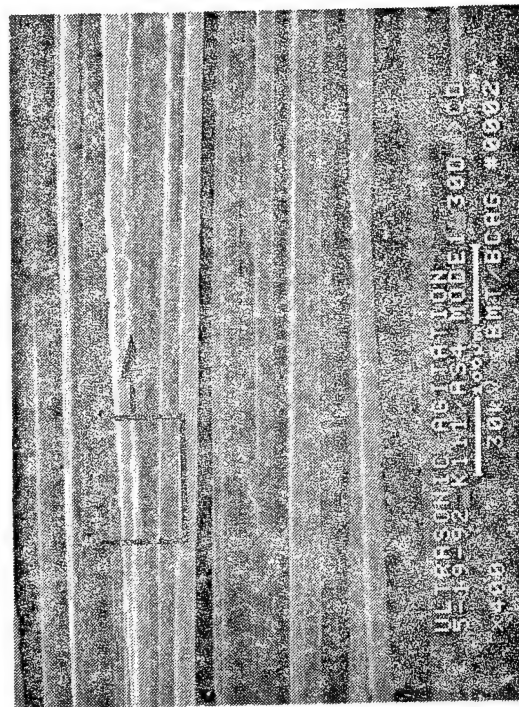
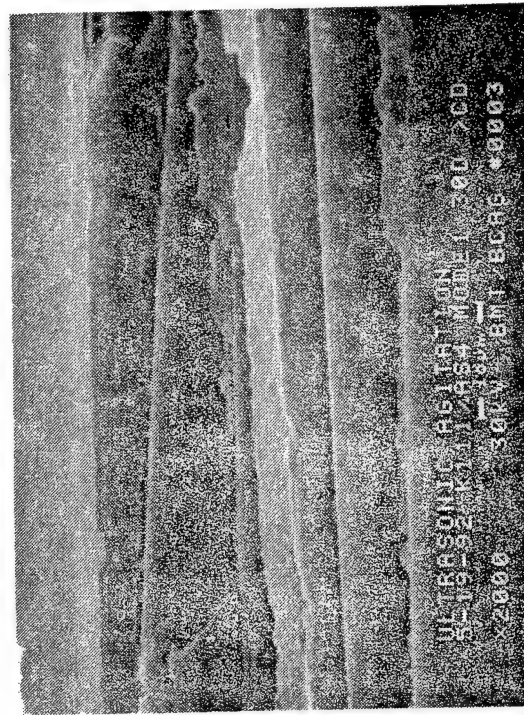
**Figure 3.2-28.** SEM Fractographs of a K111/AS4 Interlaminar Mode I Tension Fracture Surface Exposed to Ultrasonic Agitation in Distilled Water for 24 hours

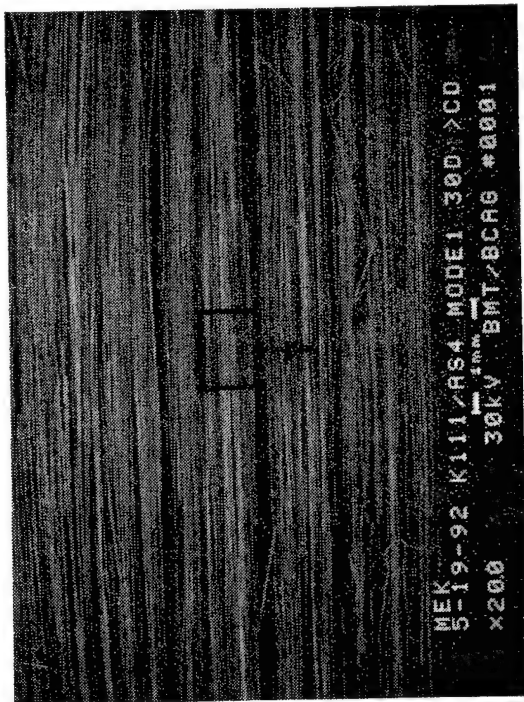
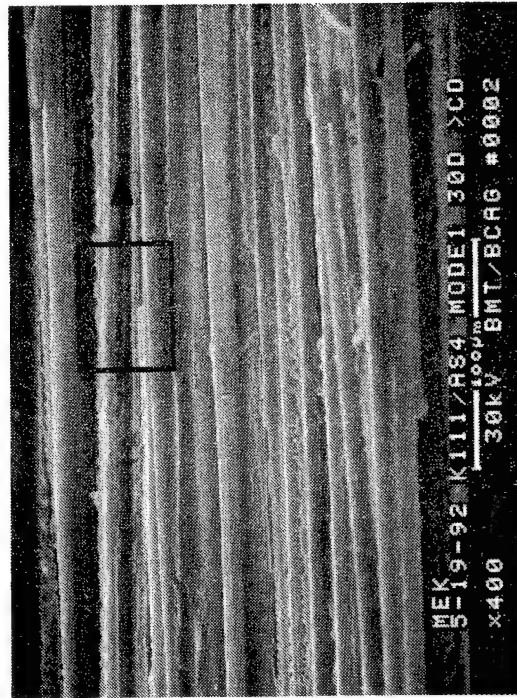
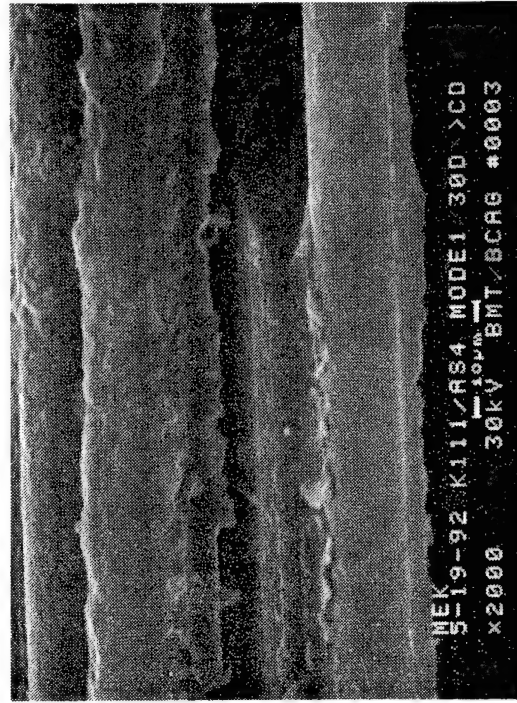
Figure 3.2-29. SEM Fractographs of a K111/AS4 Interlaminar Mode I Tension Fracture Surface Exposed to MEK for 24 Hours

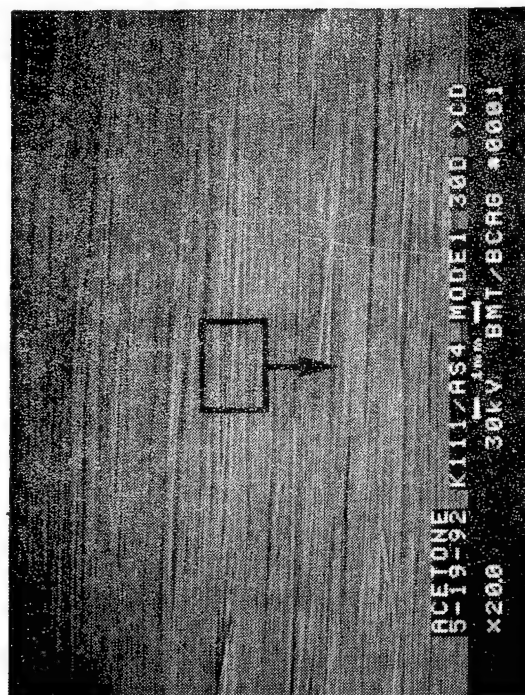
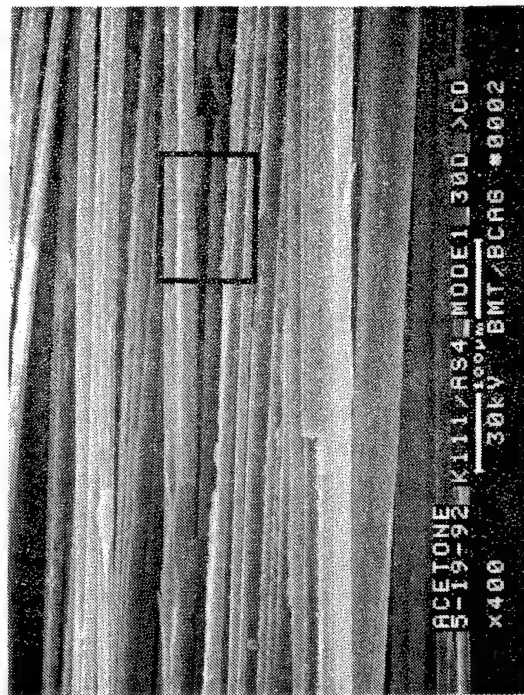
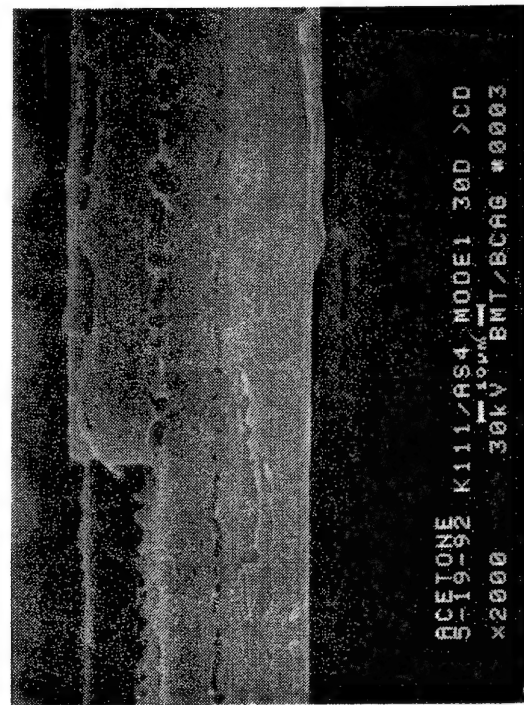
Figure 3.2-30. SEM Fractographs of a K111/AS4 Interlaminar Mode I Tension Fracture Surface Exposed to Acetone for 24 hours

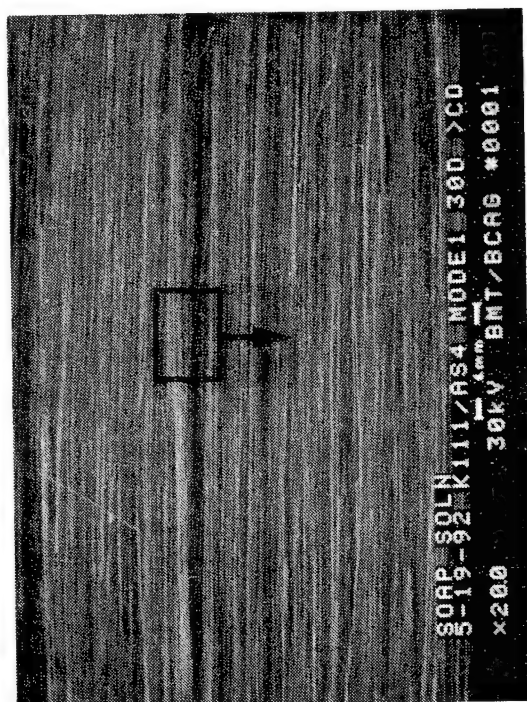
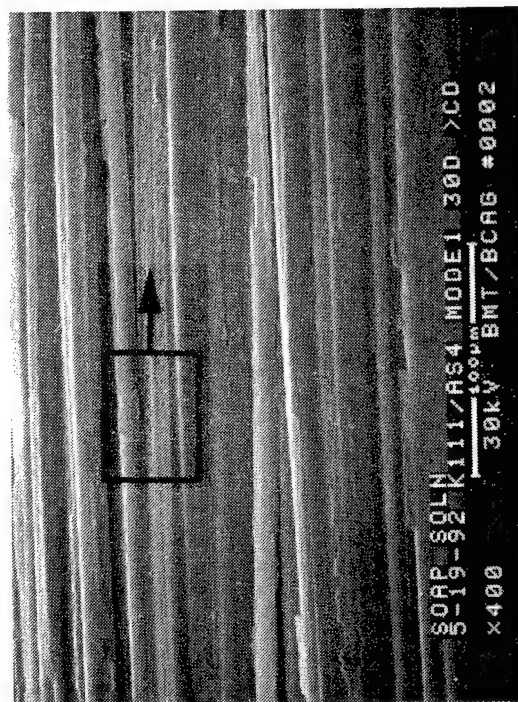
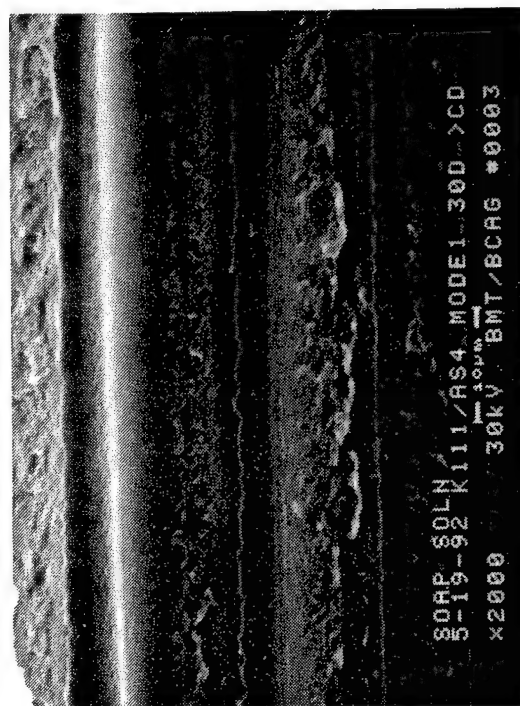
Figure 3.2-31. SEM Fractographs of a K111/AS4 Interlaminar Mode I Tension Fracture Surface Exposed to Soap Solution for 24 hours

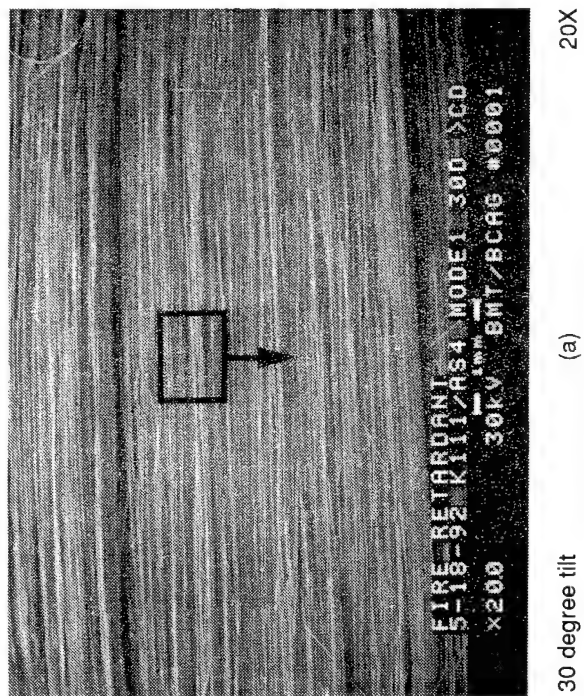
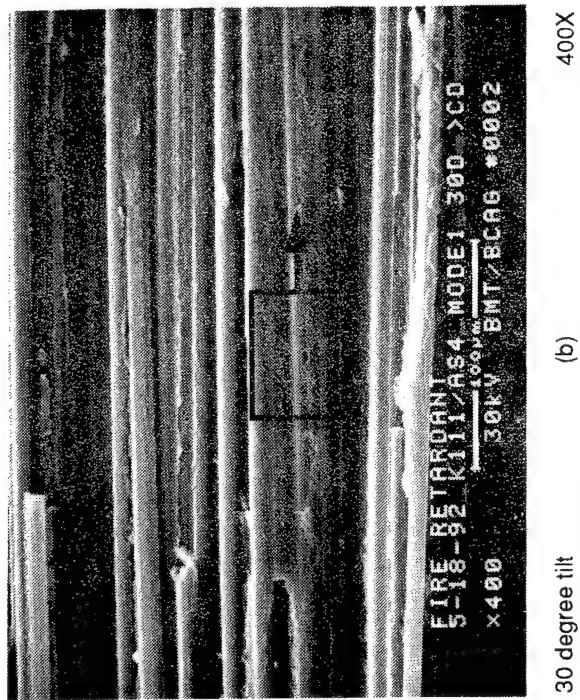
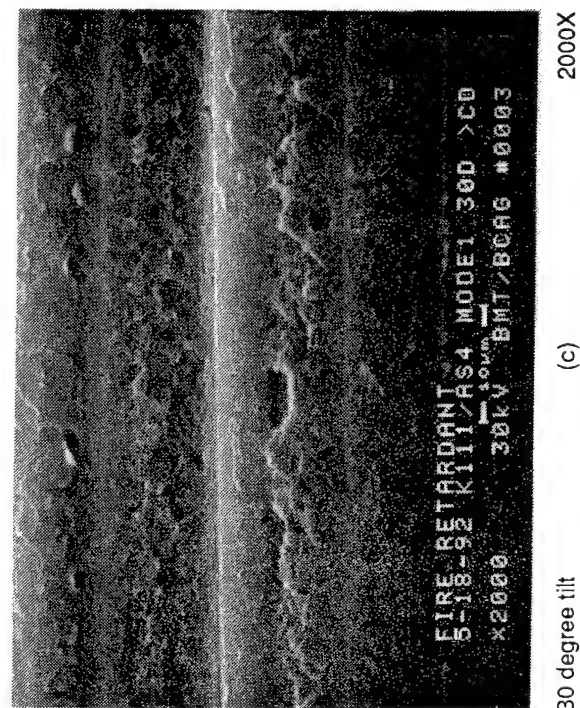
Figure 3.2-32. SEM Fractographs of a KIII/AS4 Interlaminar Mode I Tension Fracture Surface Exposed to Fire Retardant Foam for 7 Days

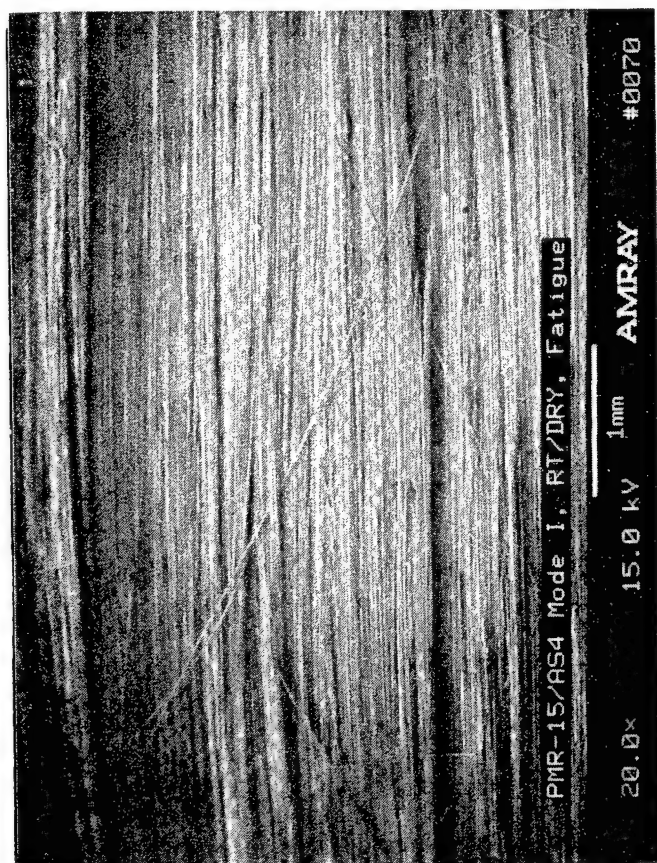
The overall surface morphology exhibited similar features as the fracture surface of a statically loaded specimen (Figure 3.3-1). Rivermarks and hackles were observed including fatigue striations. However, the striation features, which were usually located in fiber pull out troughs, were very difficult to identify even at very high magnifications (Figure 3.3-2a). These striations were also observed in resin rich regions, which resembled typical "beach marks" in fatigued metals (Figure 3.3-2b).

Figure 3.3-1. SEM Fractographs of a PMR-15/AS4 Interlaminar Mode I Tension Fatigue Fracture Surface, RT/Dry

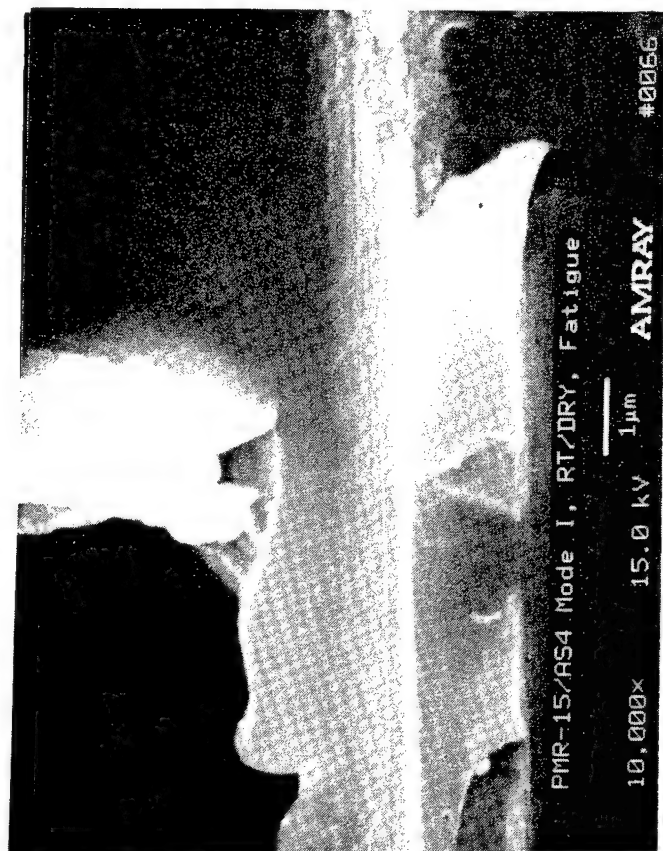
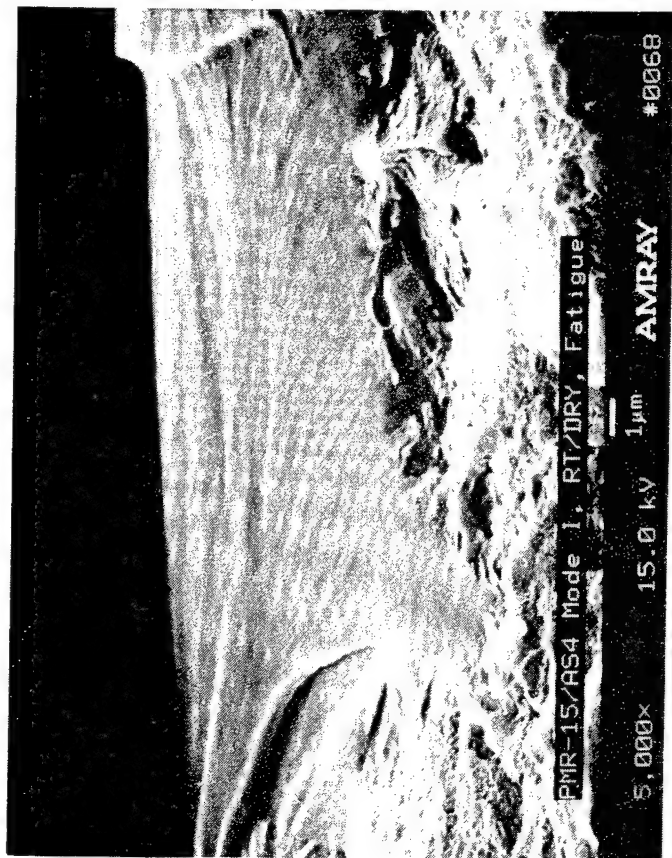
Figure 3.3-2. High-Magnification SEM Fractographs of a PMR-15/AS4 Interlaminar Mode I Tension Fatigue Fracture Surface, RT/Dry

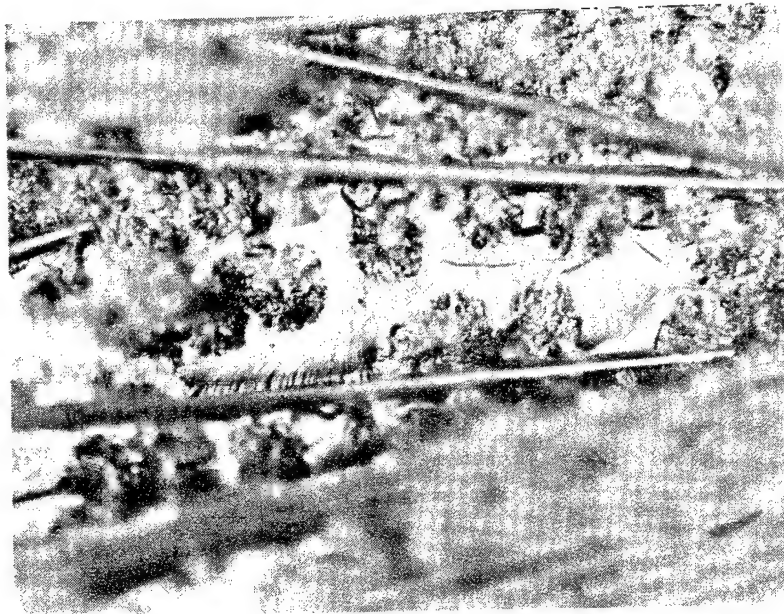
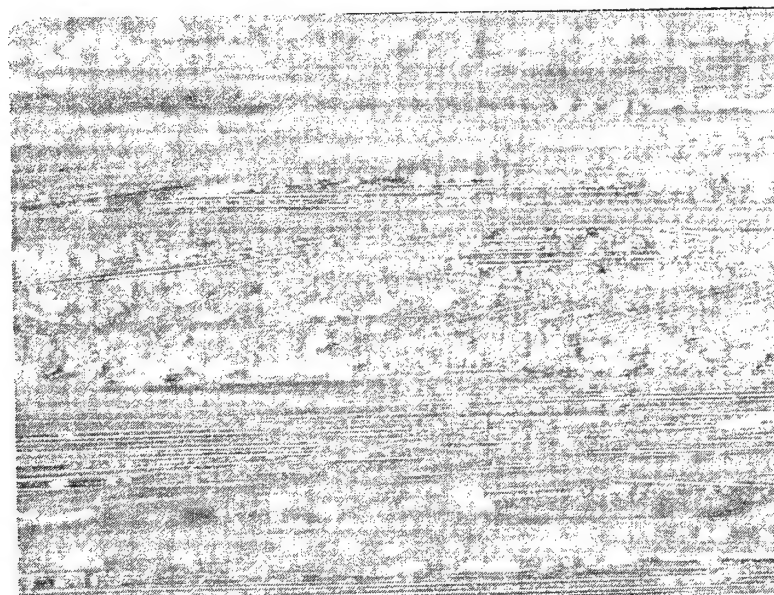
Figure 3.3-3. Optical Fractographs of a PMR-15/AS4 Interlaminar Mode I (Tensile) Fatigue Fracture Surface, 350° F

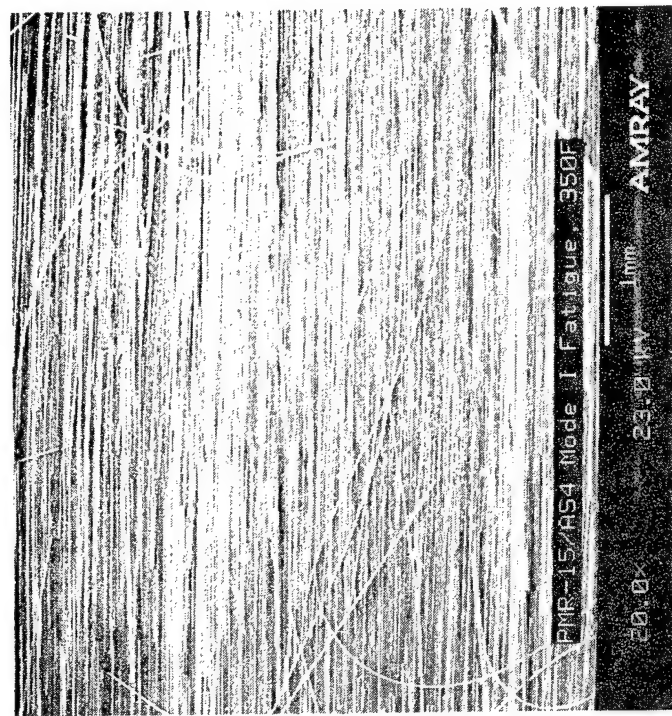
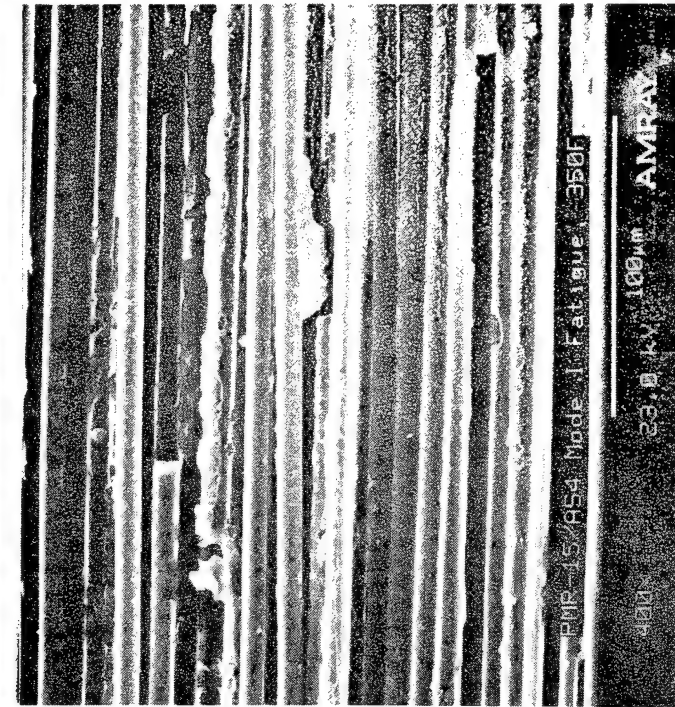
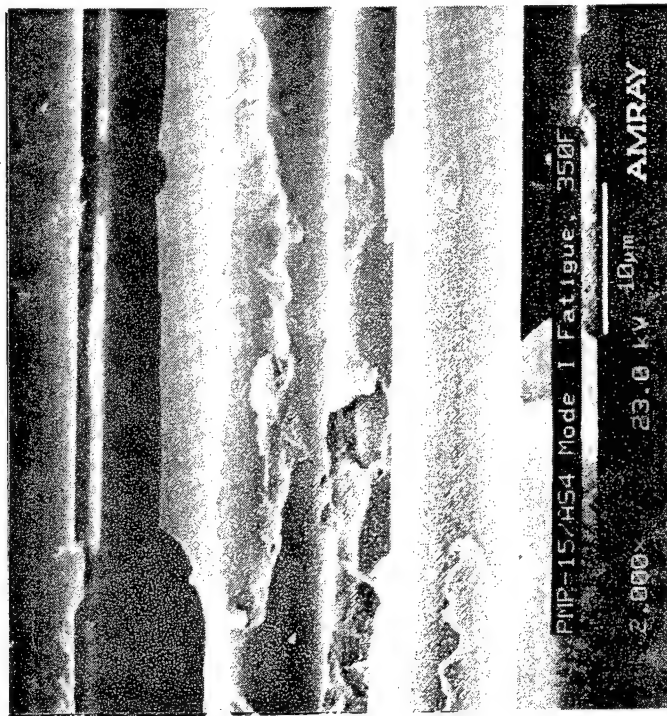
However the 350°F specimen fracture surface did not exhibit the typical mode I (tension) features. The fracture features were not distinct enough to determine the overall crack propagation direction

Figure 3.3-4. SEM Fractographs of a PMR-15/AS4 Interlaminar Mode I (Tensile) Fatigue Fracture Surface, 350° F

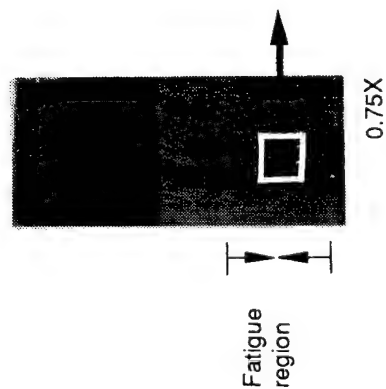
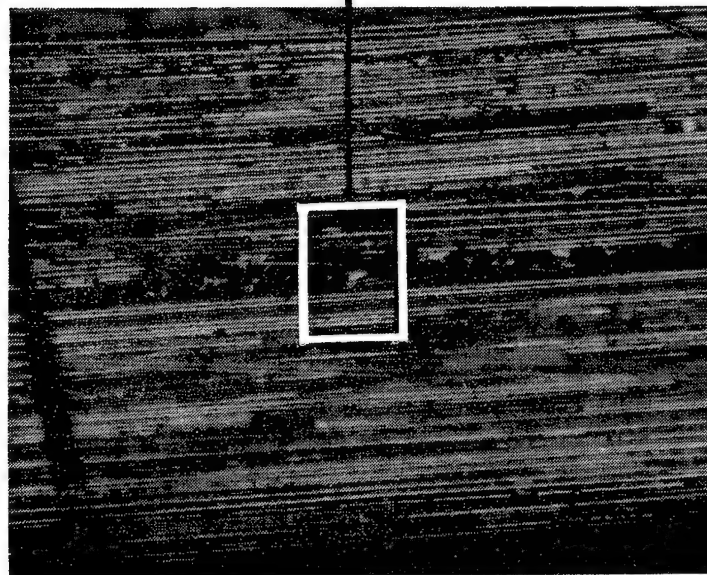
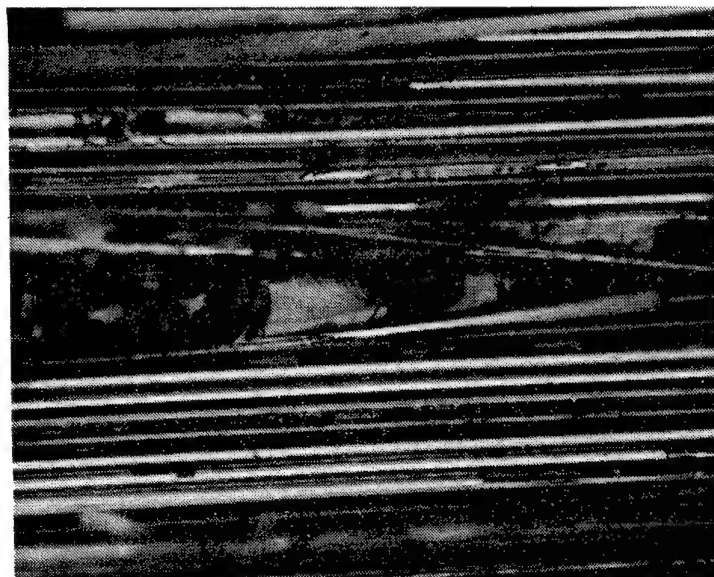
Figure 3.3-5. Optical Fractographs of PMR-15/AS4 Interlaminar Mode II (Shear) Fatigue, Room Temperature, High Stress

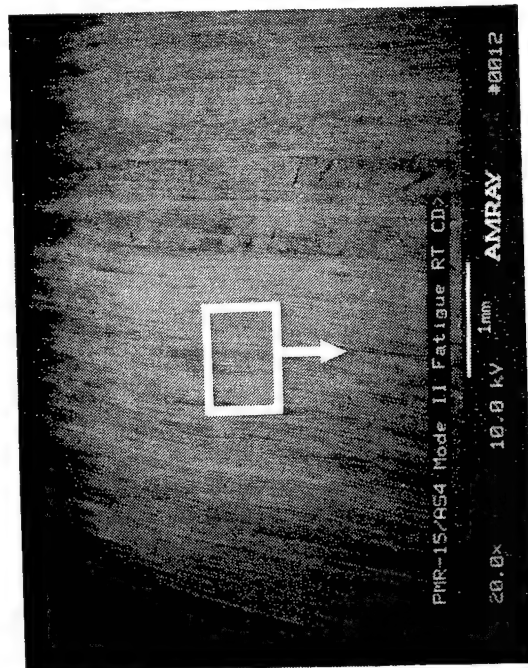
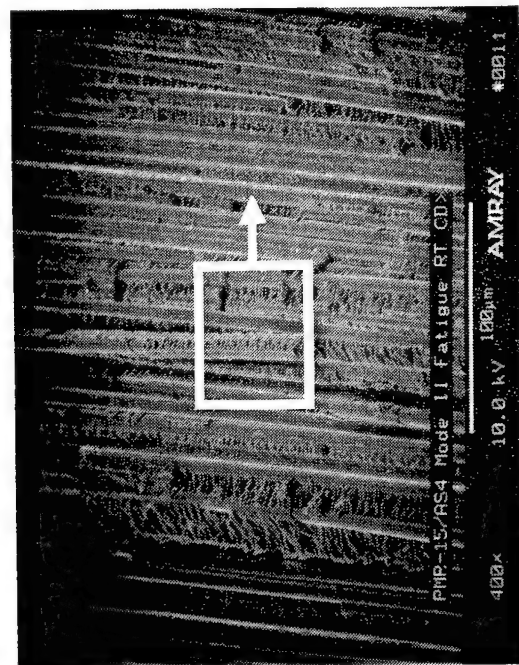
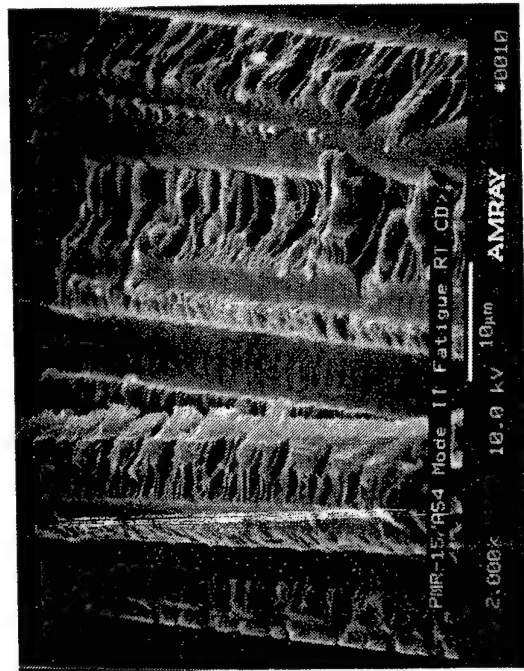
Figure 3.3-6. SEM Fractographs of a PMR-15/AS4 Interlaminar Mode II (Shear) Fatigue Fracture Surface, Room Temperature

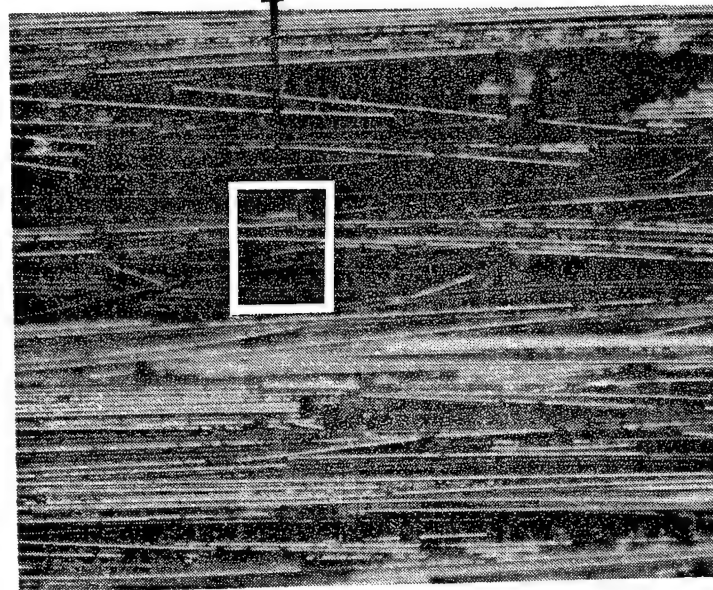
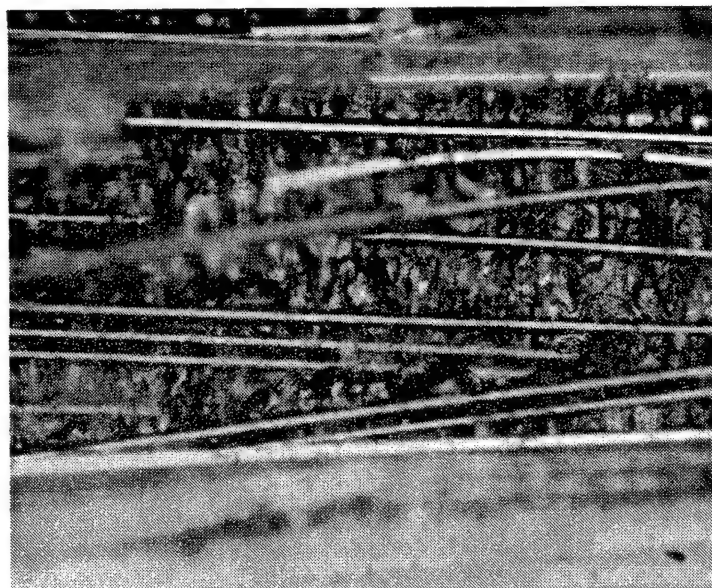
Figure 3.3-7. Optical Fractographs of PMR-15/AS4 Interlaminar Mode II (Shear) Fatigue, 350° F, High Stress

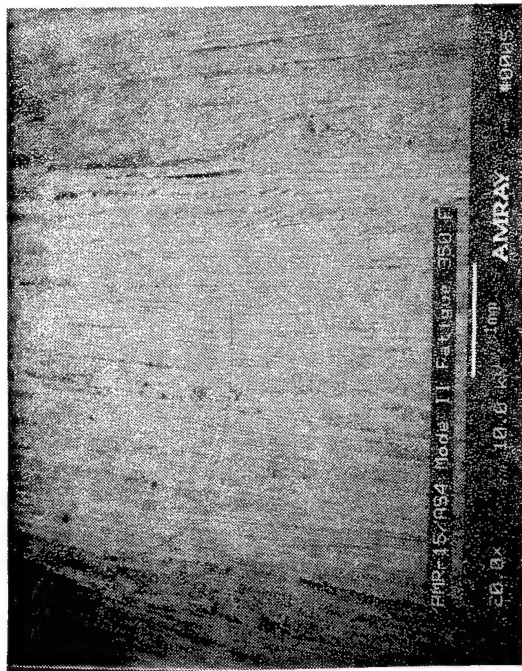
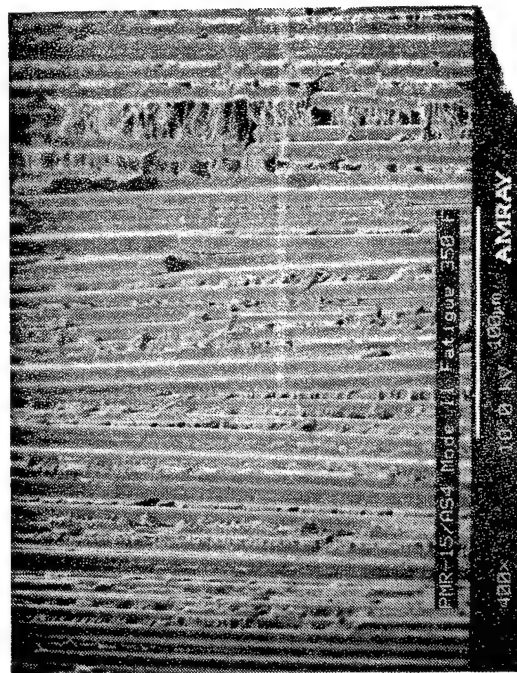
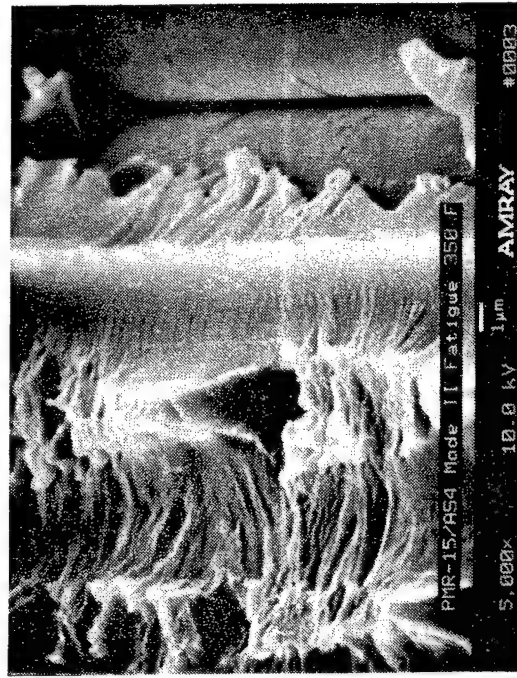
Figure 3.3-8. SEM Fractographs of a PMR-15/AS4 Interlaminar Mode II (Shear) Fatigue Fracture Surface, 350°F

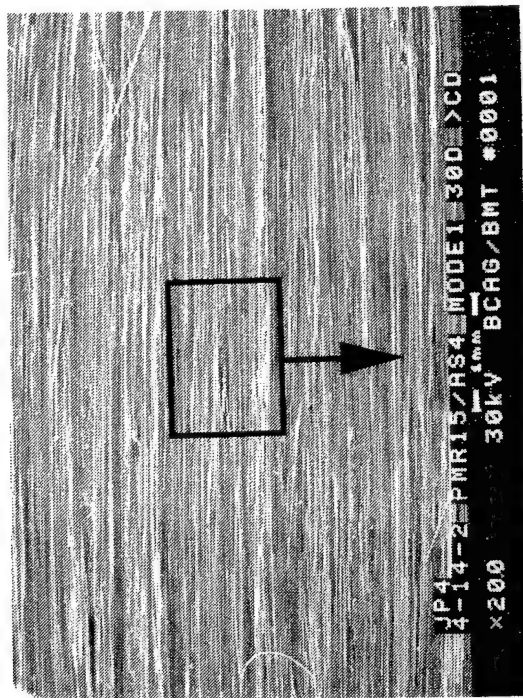
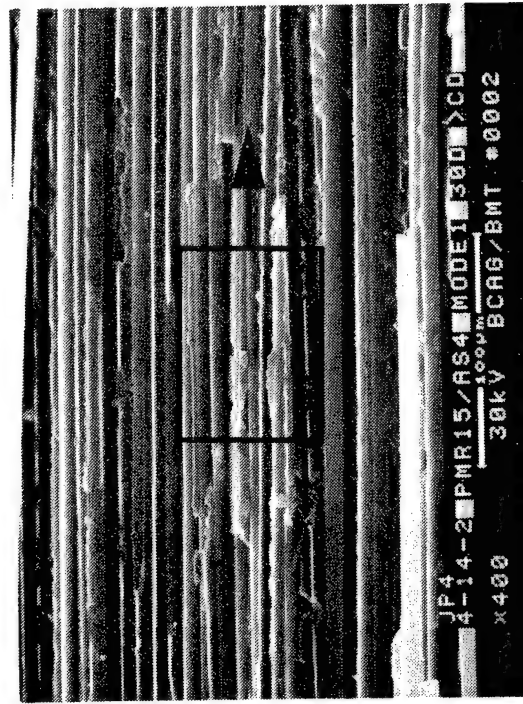
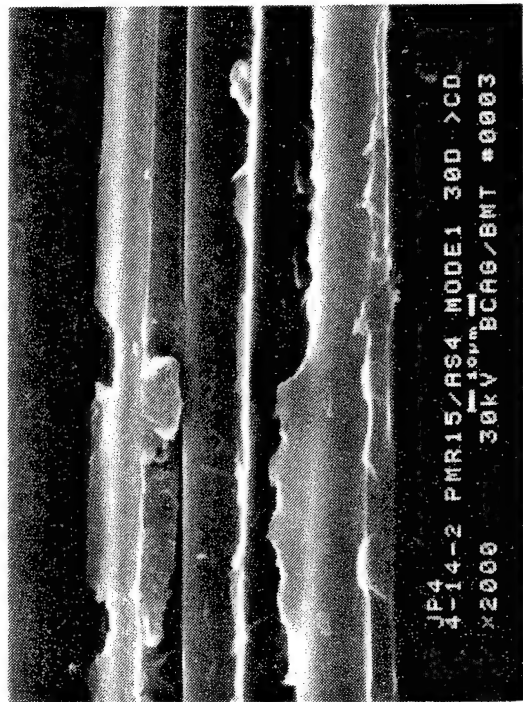
The effects of the exposure did not affect the fracture morphology to any noticeable degree. All of the characteristic mode I surface features were easily identified (Figure 3.3-9 through 3.3-15).

Figure 3.3-9. SEM Fractographs of a PMR-15/AS4 Interlaminar Mode I Tension Fracture Surface Exposed to JP4 Jet Fuel for 7 Days

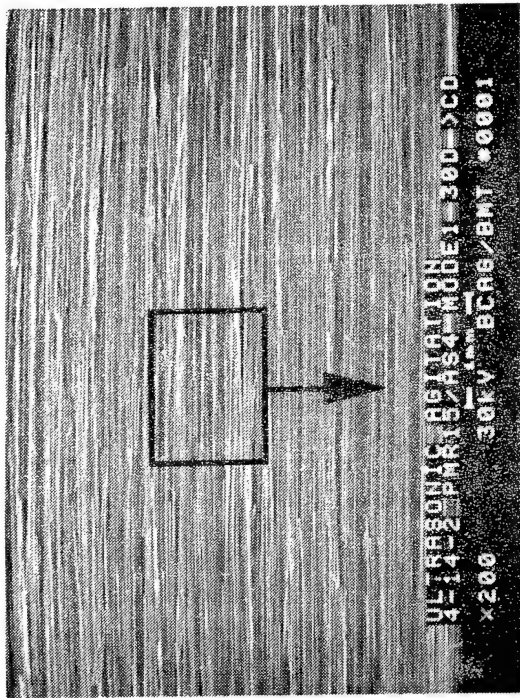
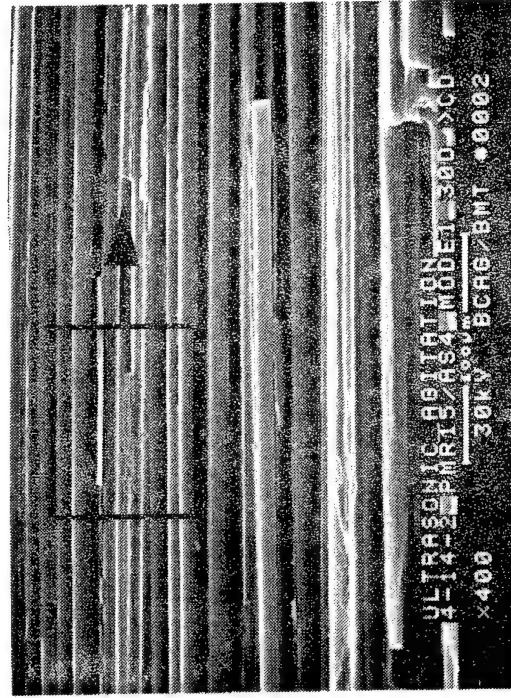
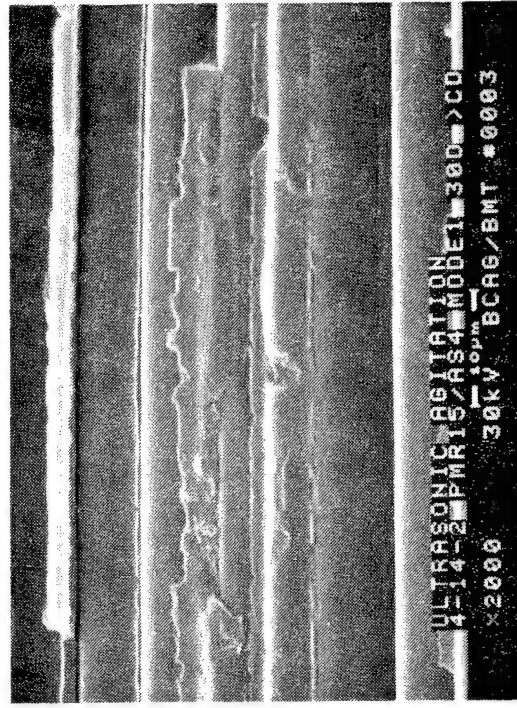
Figure 3.3-10. SEM Fractographs of a PMR-15/AS4 Interlaminar Mode I Tension Fracture Surface Exposed to Ultrasonic Agitation in Distilled Water for 24 hours
